Protocol Inspection Report By

For The Home Of:  
**Mr. & Mrs. Sam A. Sample**  
**123 Main Street**  
**Our Town, USA 12345**

Settlement # 1234-56789

## Settlement Inspection Summary

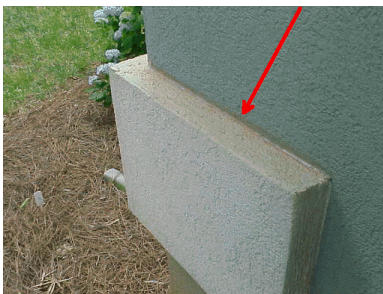
Some quoins have failing sealants - touch up all as

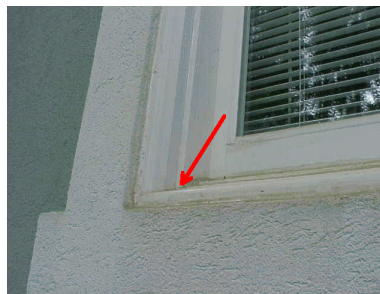
Some failed sealants noted at miters - touch up all as

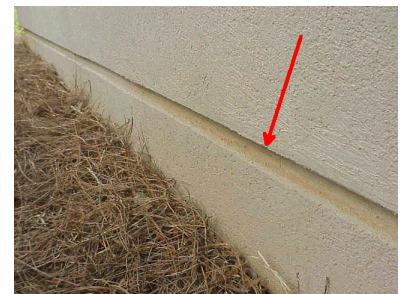
Good termite band

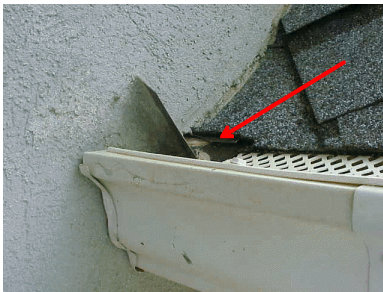
Gap in flashing overlap - high readings / poss damage below

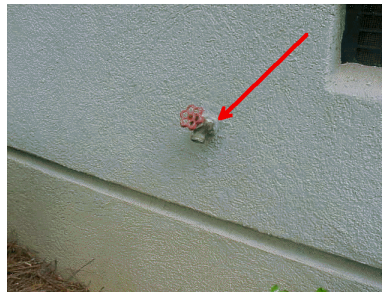
Seal all utility breaches

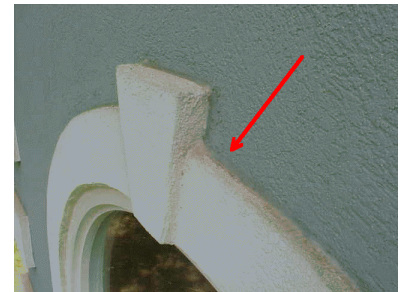
Accent well sealed

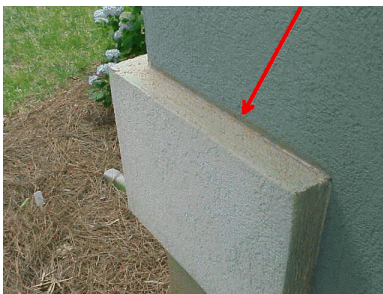
Some quoins have failing sealants - touch up all as

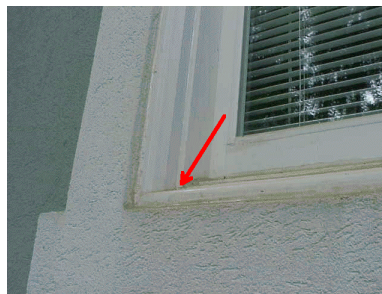
Some failed sealants noted at miters - touch up all as

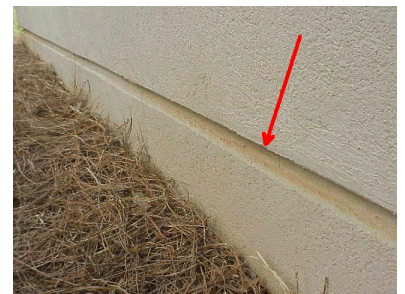
Good termite band
